# **Field Report for Airborne Data Collected In Support of US EPA Region 6 Intercontinental Terminals Company LLC Fire 8 April 2019**

ASPECT was requested to fly the tank farm, confluence and downwind areas on the morning of 8 April 2019. This report summarizes the findings of the mission.

## **Data Results Flight 21, 8 April 2019**

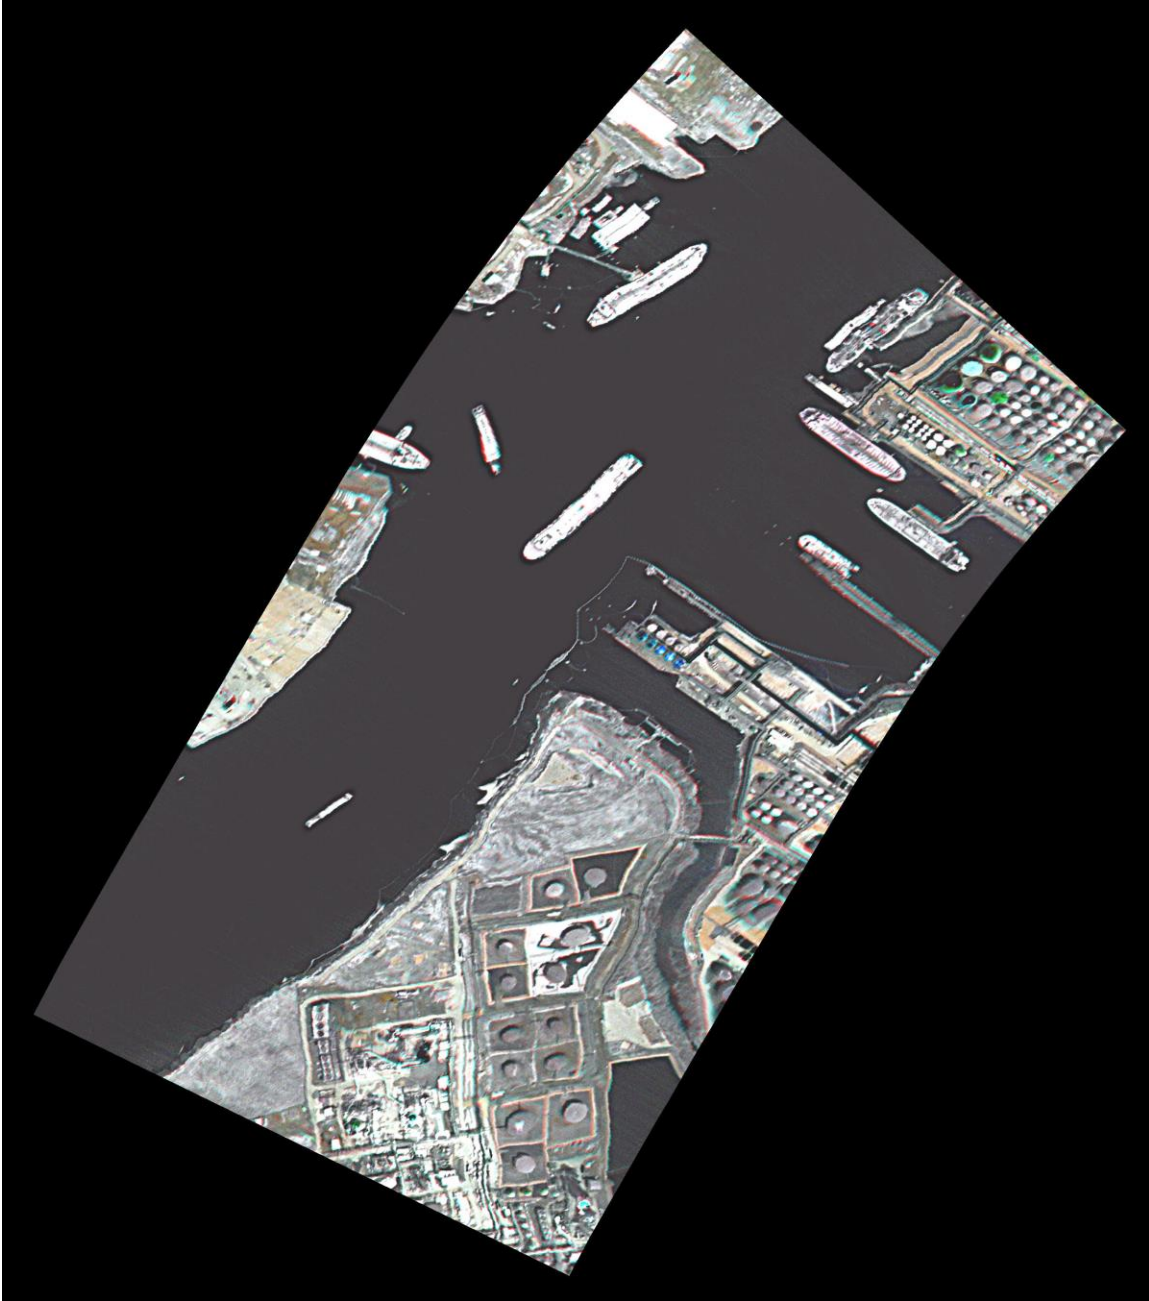
An IR image of the confluence area is given in Figure 4. A significant reduction in trapped product is evident. The remaining product seems to be along the southern booms on the ship channel with what appears to be some material pushed along the booms on

the channel side of the boom. Based on the IR imagery there appears to be no sheen leaking from the booms so the material on the outside of the booms may be channel debris.

Figure 4: IR Image of Contained Oil 8 April 2019, Fight 21, Run 5

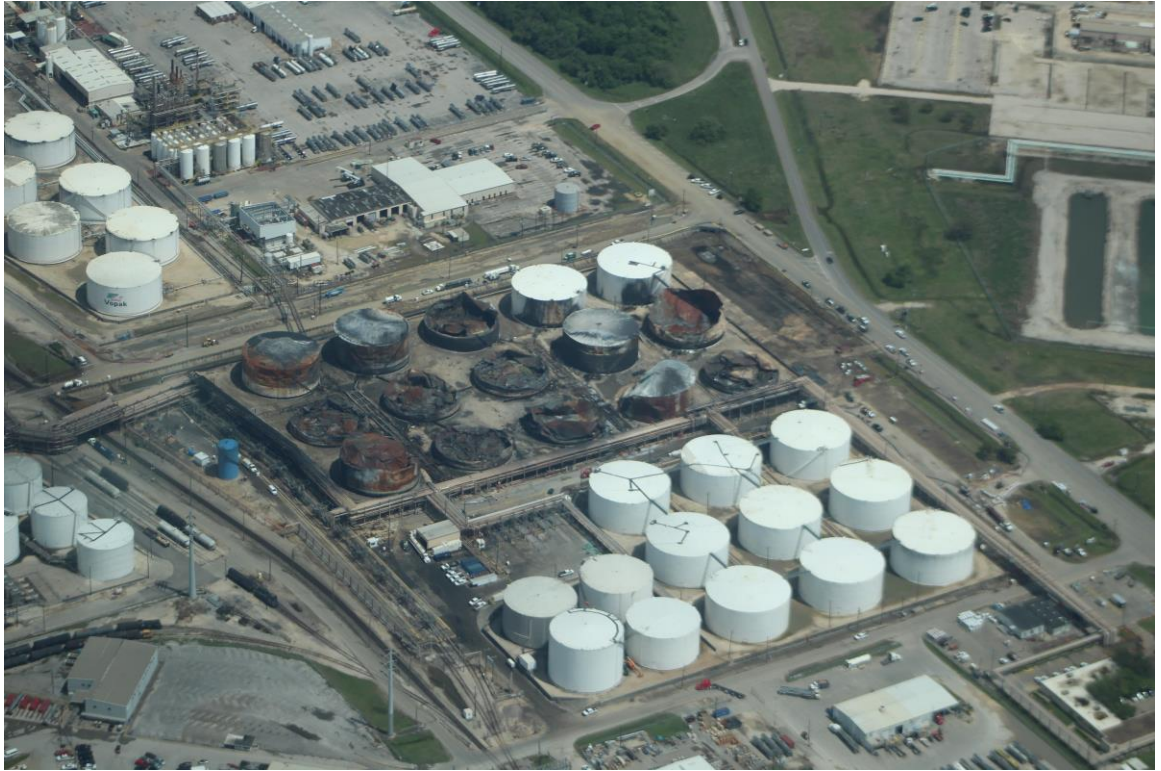
A full set of high resolution aerial digital photography was collected as part of the flight. Figure 6 shows a representative overhead image collected as part of each pass over the tank farm. Analysis of the image shows no change from imagery collected on 3 April 2019. The dark hue on the left side of the image is a cloud shadow. Figure 7 shows an oblique image of the tank farm and confirms no change from the 3 April 2019 flight.

Figure 7: Oblique Image of the Tank Farm (looking north) , 8 April 2019 Flight 21

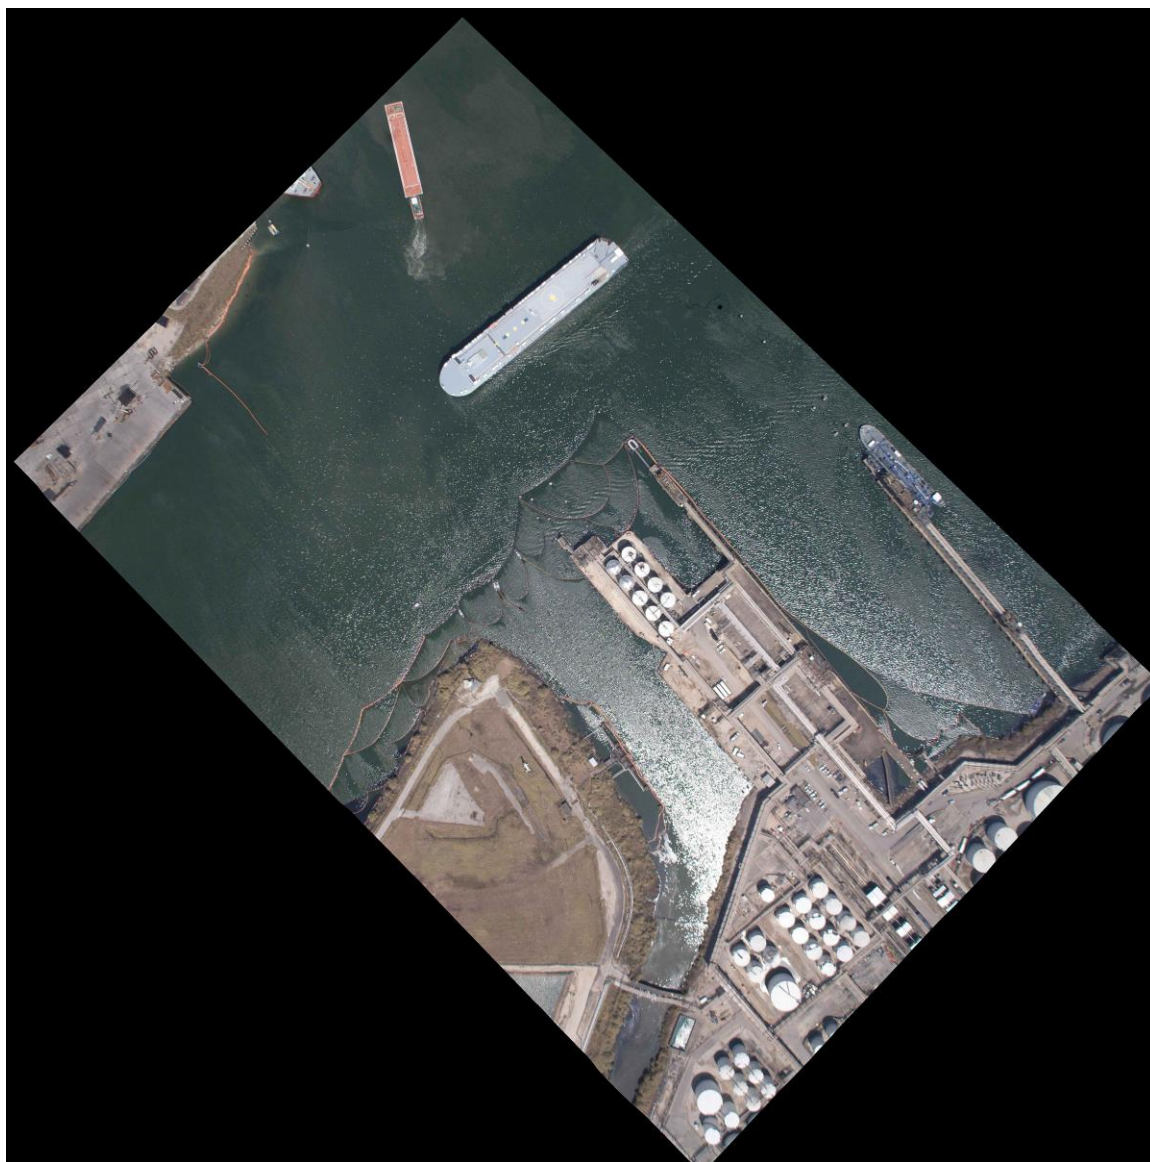
The confluence area aerial image is given in figure 9. Examination of the image shows a small amount of dark product trapped in the channel booms. No significant leakage of product or sheen is present. An oblique of the confluence area confirms that material is located on the outside of the channel booms (most likely pushed into position by the wind). No sheen is evident in the image.

Figure 8: Aerial Image of the Ship Channel Boom Area, 8 April 2019, Flight 21

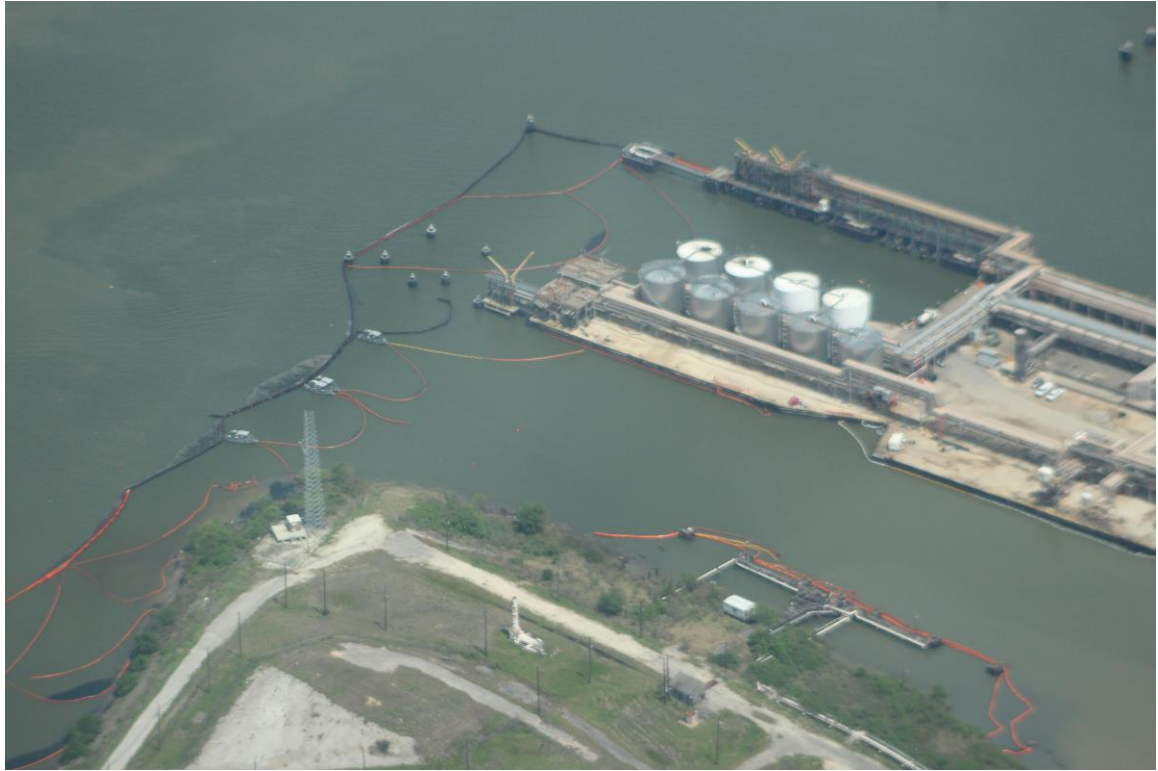
Figure 9: Oblique Image of the Ship Channel Boom Area, 8 April 2019, Flight 21
